# Hierarchical Inspection System Using Visual and MFL Probe Robots

## ABSTRACT

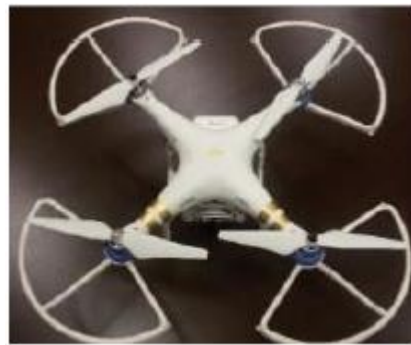
Figure 1. Phantom Pro III UAV used in this work for VBI part

For the VBI system, the images can be obtained by any means possible as long as the images are obtained with fixed initial reference positions for appropriate registration of successive images. Hence, images can be obtained from static cameras located at pre-defined places [14], or they can be movable [15]. Since the target of this work is related to a perpendicular image scan of the structure in order to develop the best surface scan, the cameras must be as perpendicular to the surface as possible. Hence, a commercially available UAV, Phantom Pro III UAV [20] as shown in Figure 1, has been used for providing the VBI component of the system with its stabilized 4K camera.

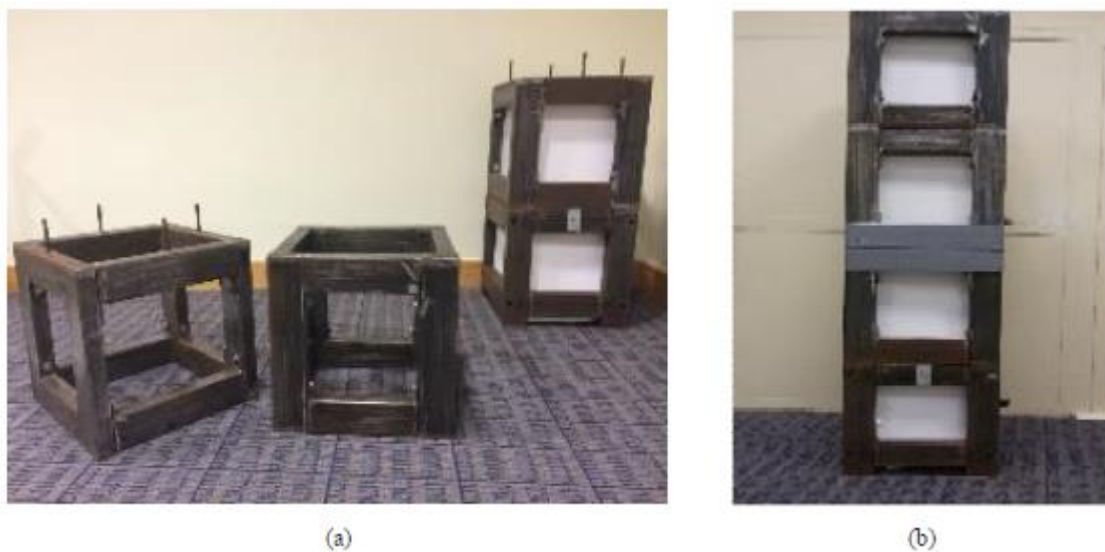
Figure 4. Structure (a) Cubical block and (b) final design

The selection of structure and the testing conditions is one of the critical tasks in the design of this SI system, since it must emulate the main challenges of the real world structures to as greater degree as possible. A test structure was built for performing various initial tests in the laboratory. The structure consists of four homogenous metallic cubes placed sequentially on top of each other, as shown in Figure 4.

The reason of selecting such a structure is to ensure that the conclusions obtained from this research address most of the typical civil structure problems without being loaded down with other uncertainties or scaling factors. Several experiments were in this environment in such a manner that the parameters modified by the environment, e.g., wind, camera drifts or zooming issues etc. can be avoided at first and then added in a controlled manner to test the limits of operation of the system.
